## The Story of the Norton Nursery Survey

### Ancient Footpath from Norton Park to the Walled Garden

### The Ancient Walled Garden Surrounding Wall (1740)

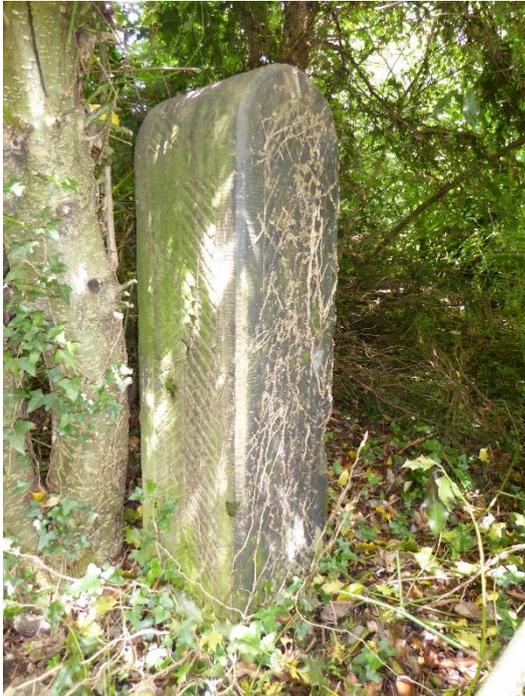
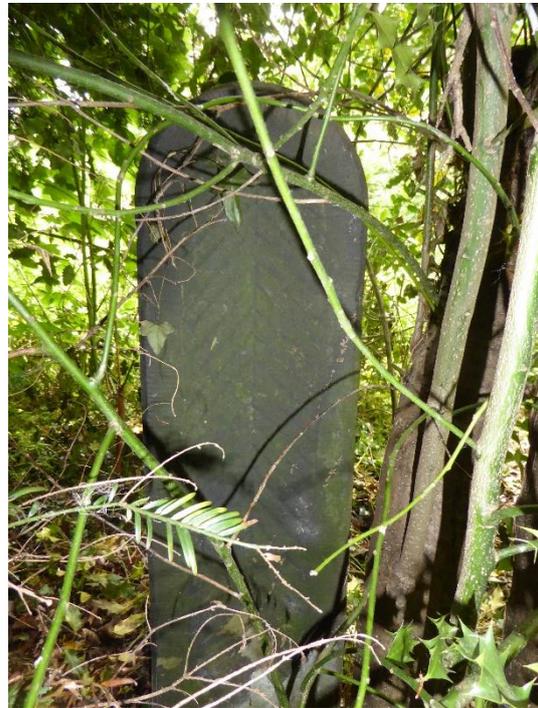
Located a stone gate hinge post forming a gateway from the Norton Park boundary to the walled garden.

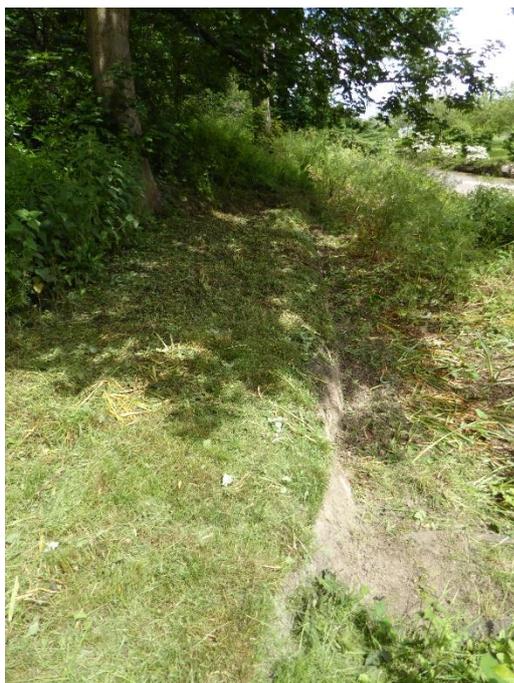
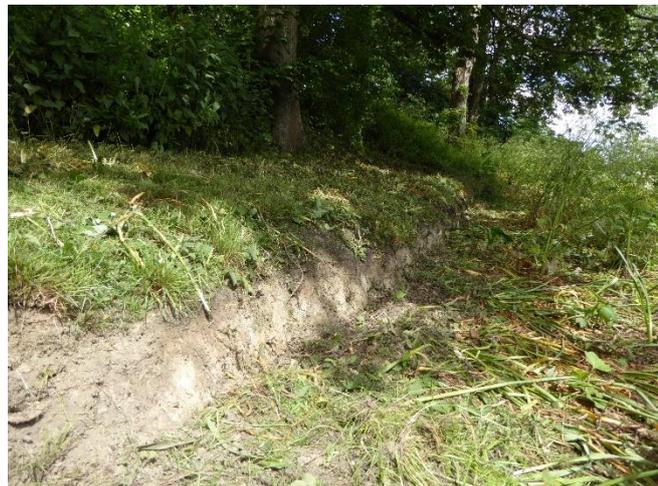
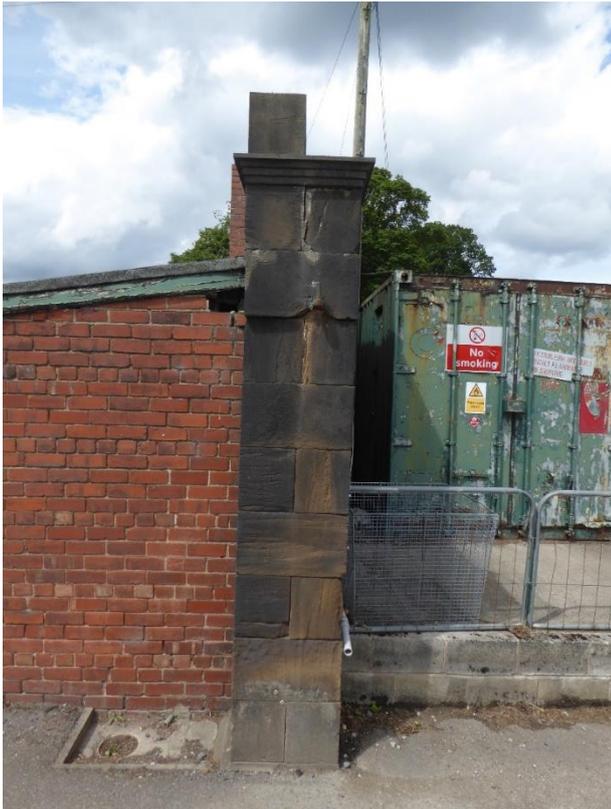
Exposed a 20m long by 1m wide section of the footpath to the walled garden (clinker based, now a grass surface). Wall garden details, an L-shaped section is all that remains here of the wall.

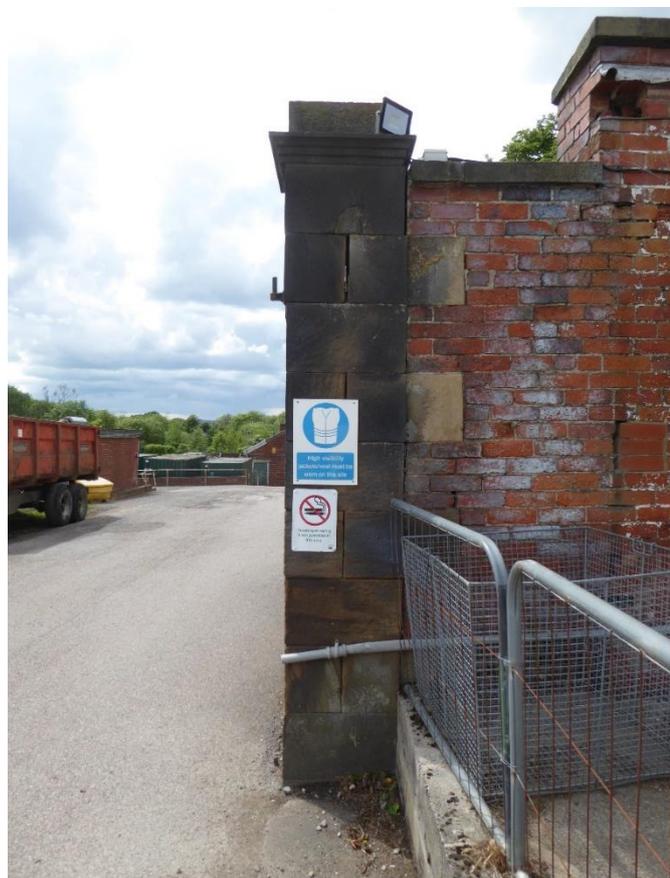
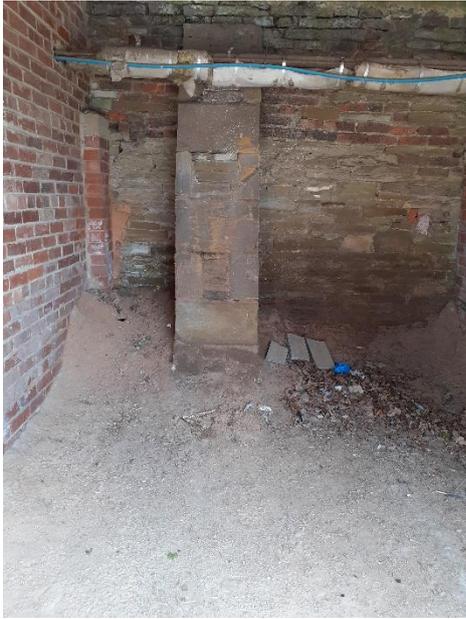
Surveyed a remaining stone gate pillar entrance into the walled garden. (Originally there were 2 gate pillars supporting double leaf heavy timber gates, painted green, complete with upper section glass panels.) NB The brick wall running south collapsed in 1979 due to undermining by the excavation of a drainage ditch on its western side.

Stone gate pillar 550mm x 550mm x 3.8m high

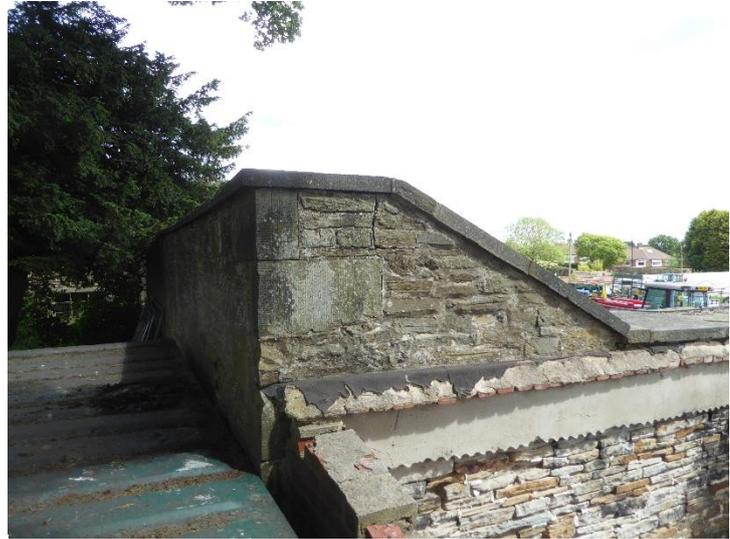
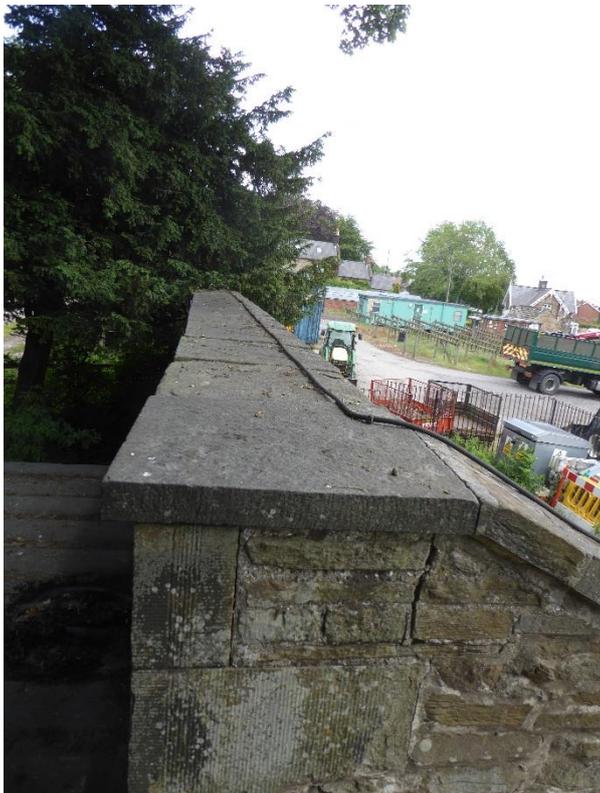
The remaining section of the wall to the garden, running north comprises a composition of stone and handmade brick complete with a stone capping along all the remaining wall. The photo shows a stone built buttress supporting the stone section of the wall (the inner section being brickwork and the outer section being stone).

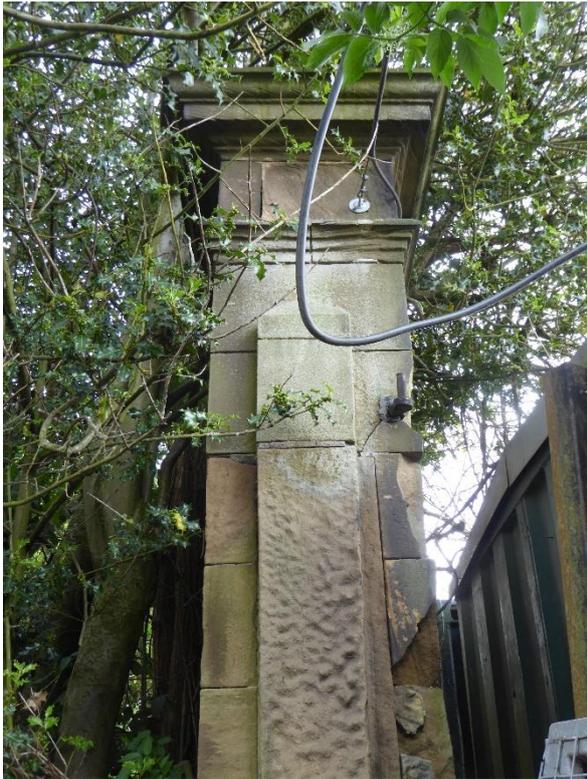
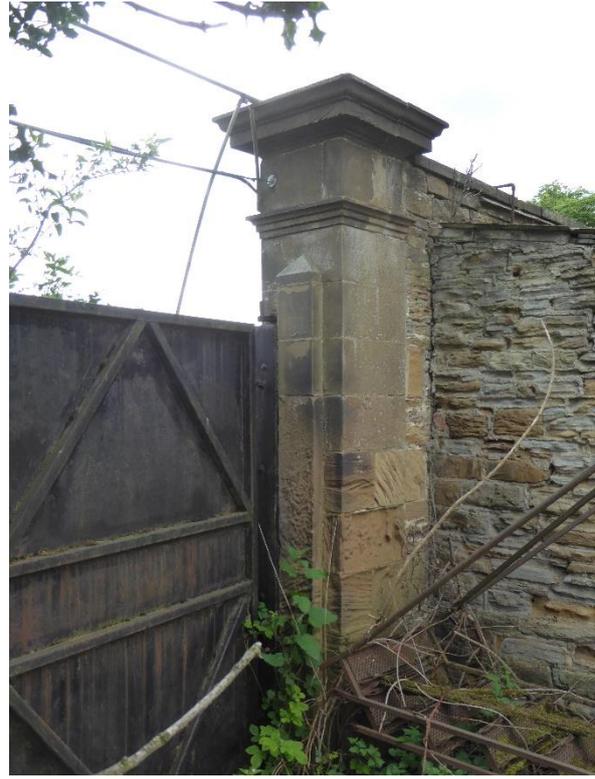
The wall changes direction, running west to east at 90° towards an entrance comprising 2 stone pillars, complete with metal double leaf gates. (These gates previously were timber and glass panelled, matching the main access gate as previously described.)

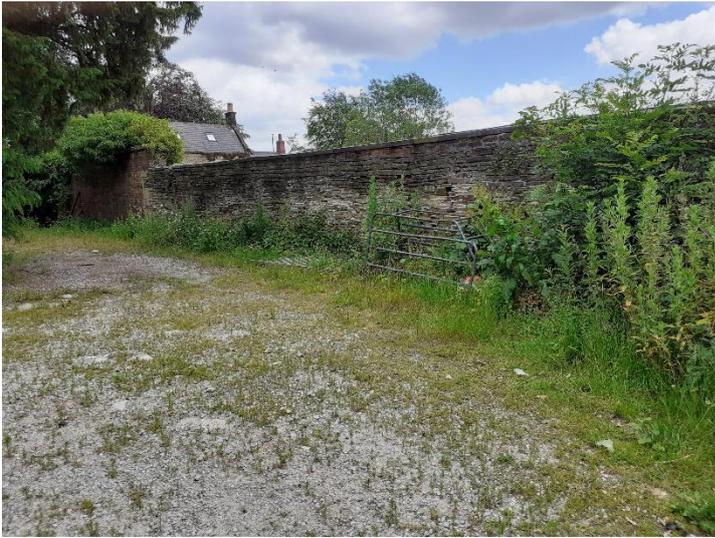
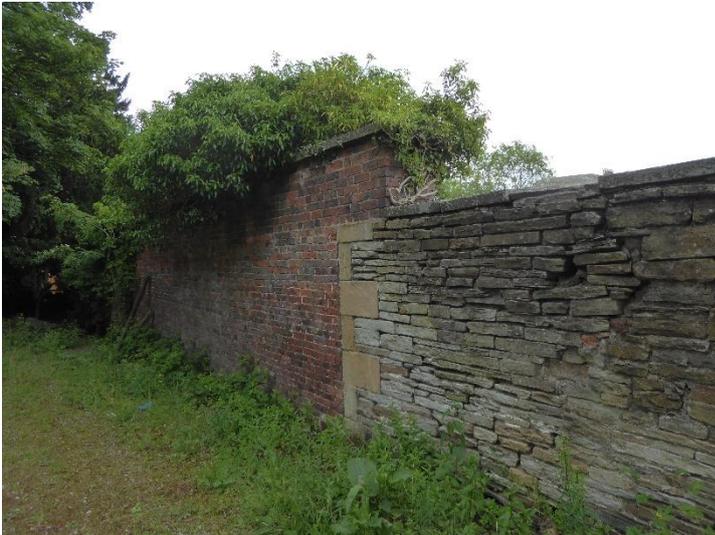
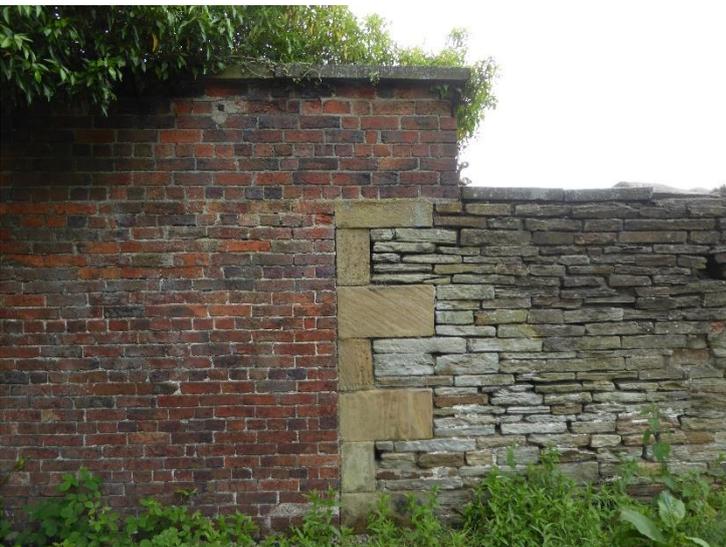
The wall changes in height and comprises all handmade brickwork complete with stone capping.

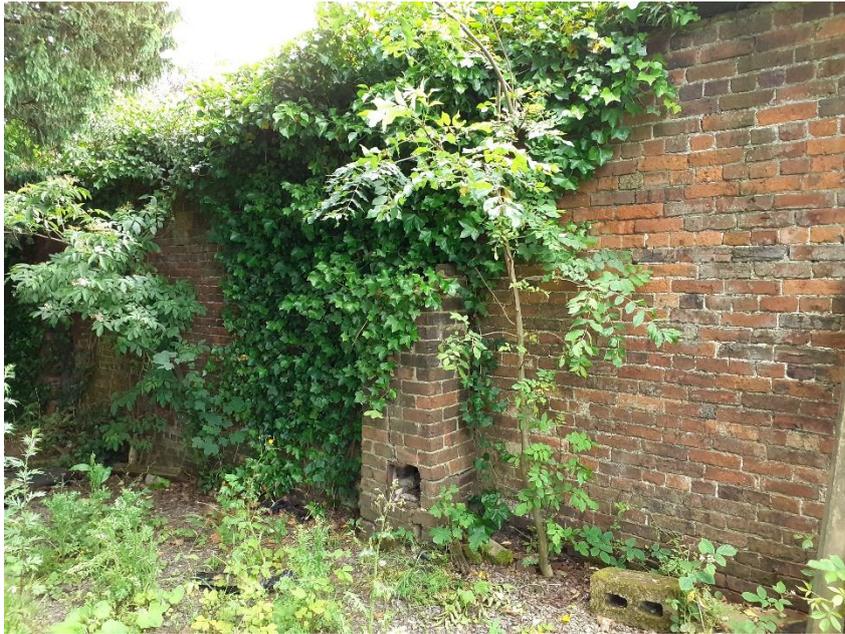
The remaining brick flue to the old boiler house (located below ground level). Which serviced the heating pipework to the lean to glass house vinery located on the south side of the wall.

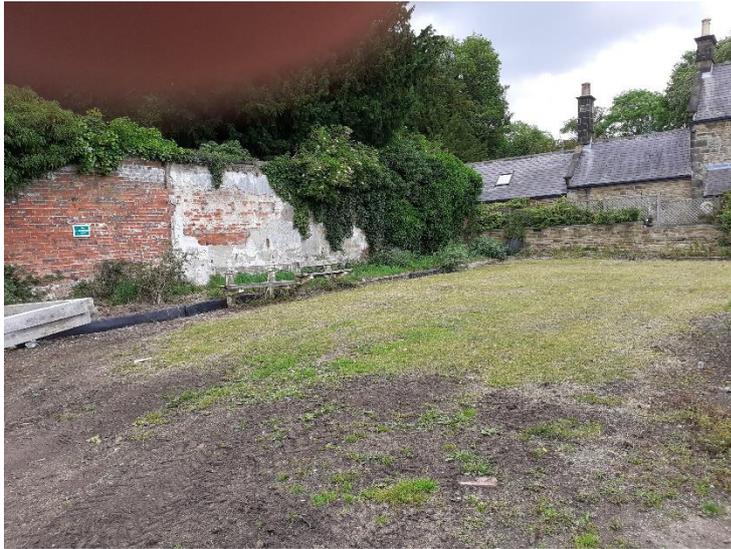
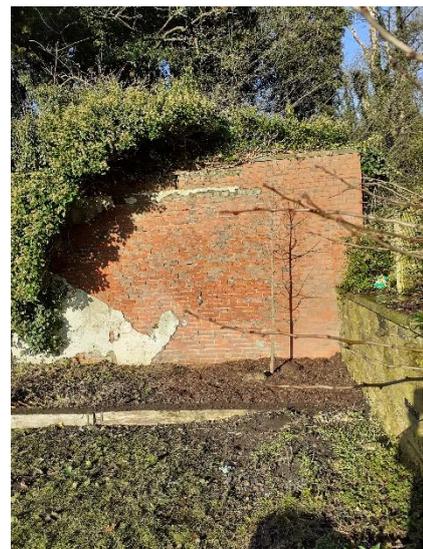
The remaining section of the wall, which also comprised a double leafed set of timber gates, finished at the kitchen wall of Chantrey Cottage. (a section of which was demolished when the cottage was sold) Located at this point where the wall joined the cottage was an historic Ginkgo Biloba tree (removed by the owners of the cottage) which would have been planted circa 1740. A replacement Ginkgo Biloba was planted 2011, in front of the remaining brick wall, on the boundary of the now privately owned cottage boundary.

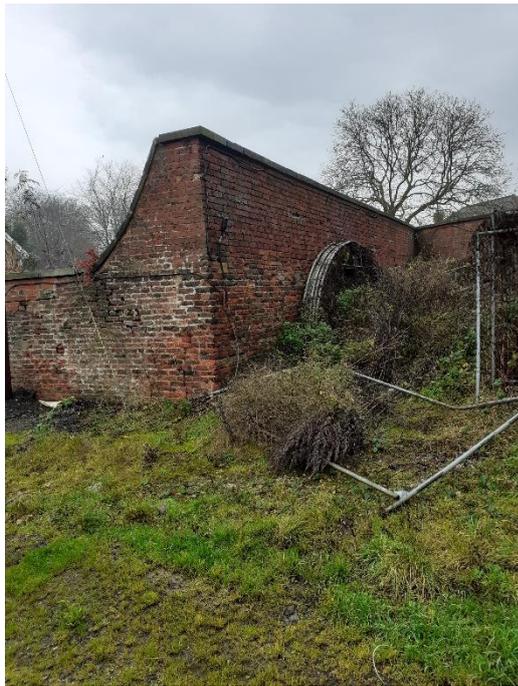
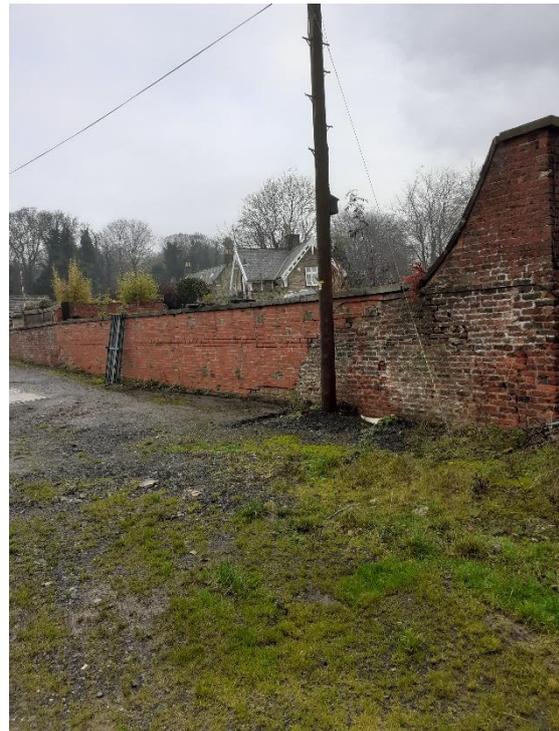
Item 3, the southern part of the wall running from west to east, this wall was constructed completely of hand-made brick and was demolished section by section over the years from 1950 onwards. The bricks were used as crushed coarse aggregate in compost making for carnations, cyclamen and begonias. The wall was gradually removed to ground level and the area then used to create turf stack provision for plant compost use. Turf from Oakes Park was placed in layers with manure between, up to a height of 1.8m. NB This section of brick wall served no further use as the boundary. The Serpentine Wall was sufficient protection to the nursery.

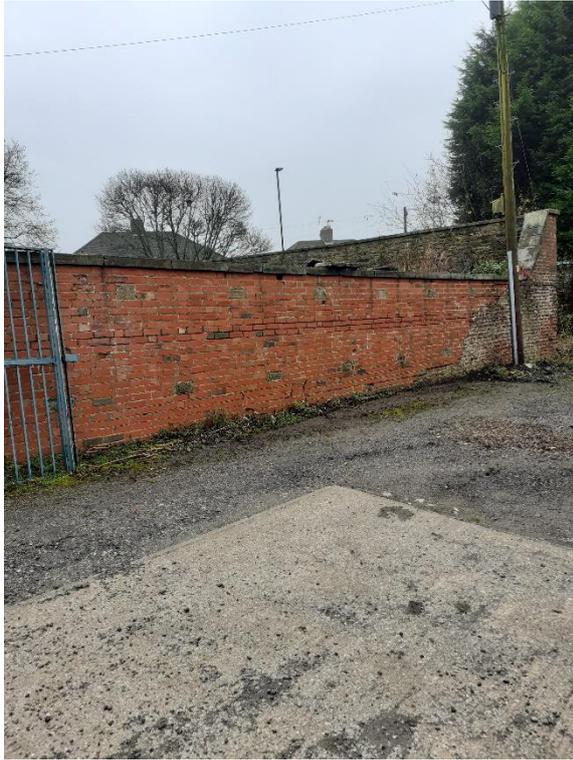
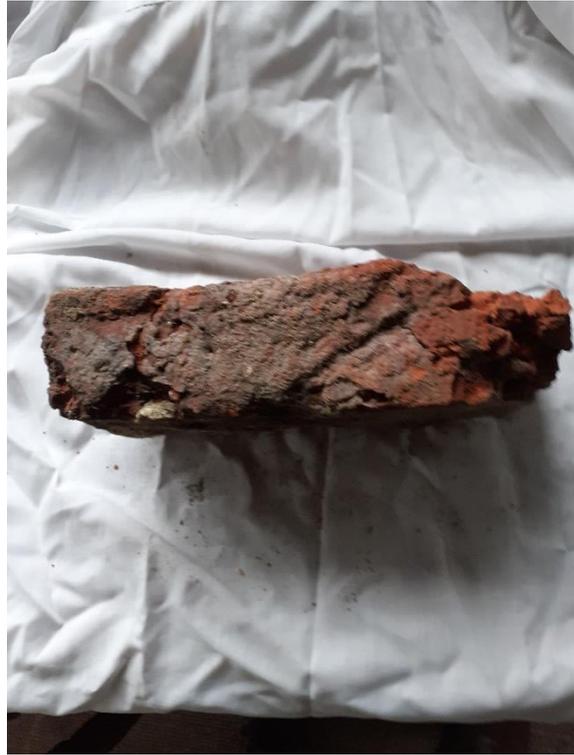
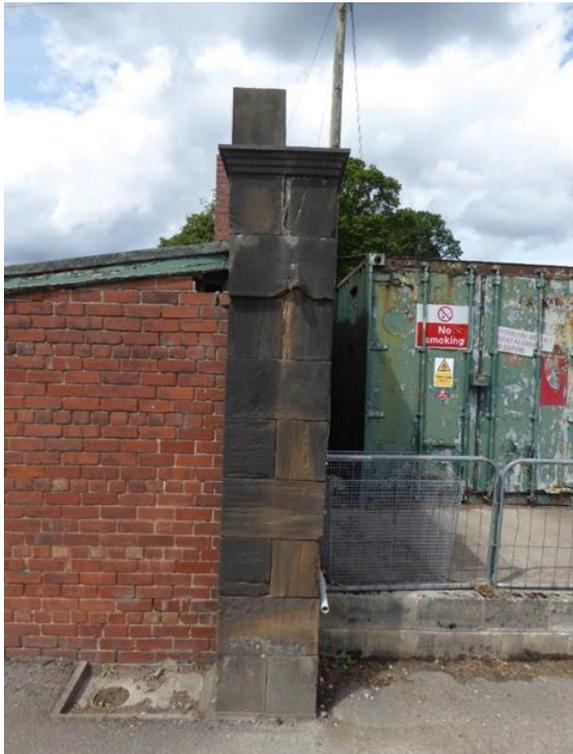
Item 4, the eastern wall is intact and runs alongside Norton Lane, the outer part being stone and the inner brick, complete with stone capping. The wall returns at 90° back into the nursery and is a similar construction to the one previously described. It then returns at 90° as a similar construction to the one previously described, part now reduced in height and it finishes at the main drive access to the nursery.

The stone cappings are of consistent size throughout the wall construction, dimensions 560mm x 560mm x 100mm thick. Stone gate posts 550mm x 550mm x 3.58m high. Handmade bricks (?)

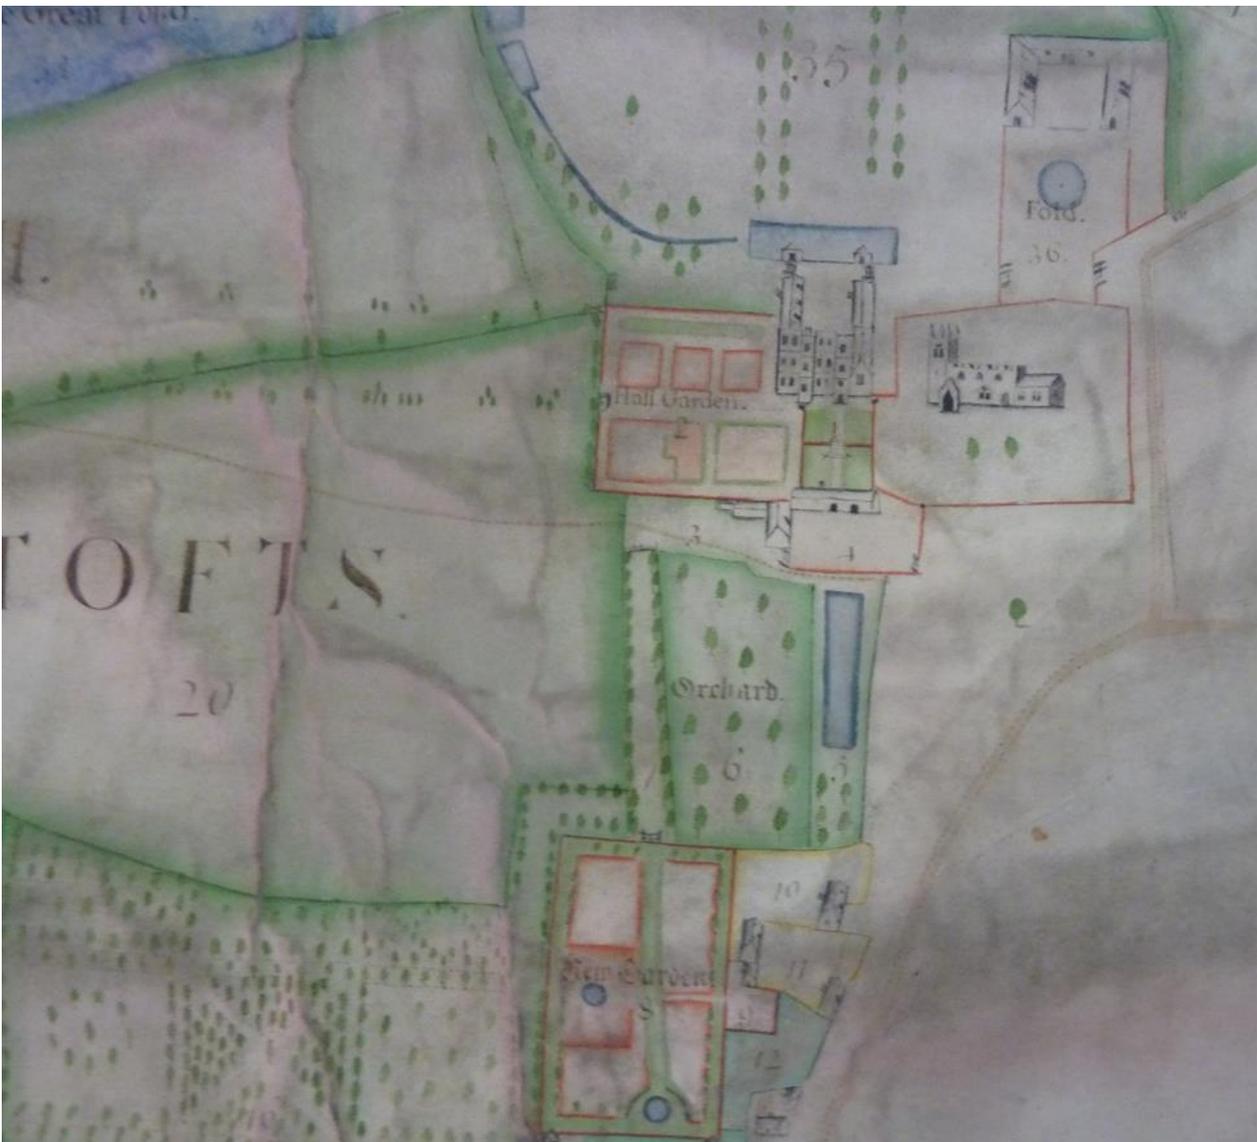
Extract from 1741 Map

Stone Built Bothy (See plans 1741 and 1883)
