The Story of the Coach House Pond Survey (20th June 2019)

The Coach House Pond

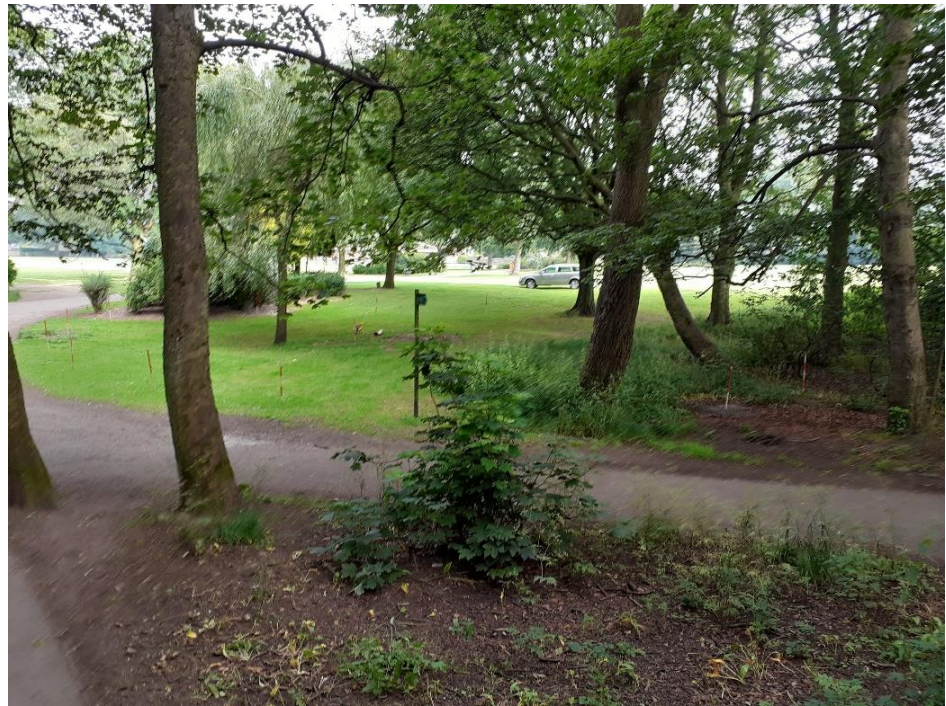
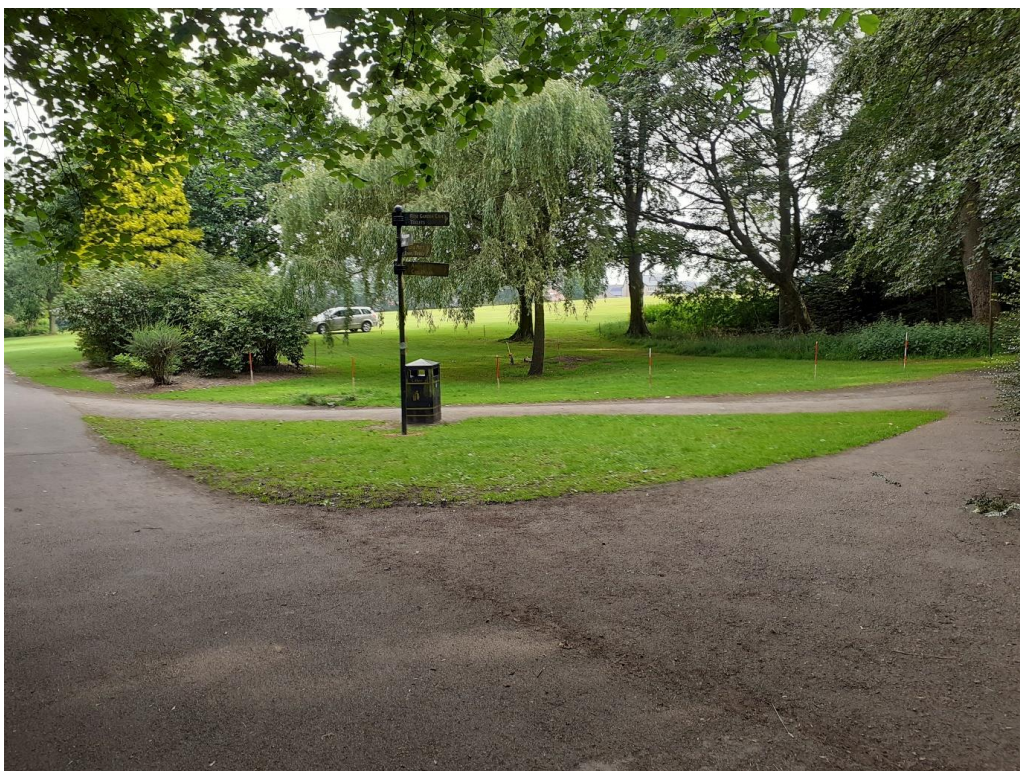
(A)

The photographs show the layout of the pond, picked out with ranging poles.

Looking North, towards Hemsworth Road

Looking
North East

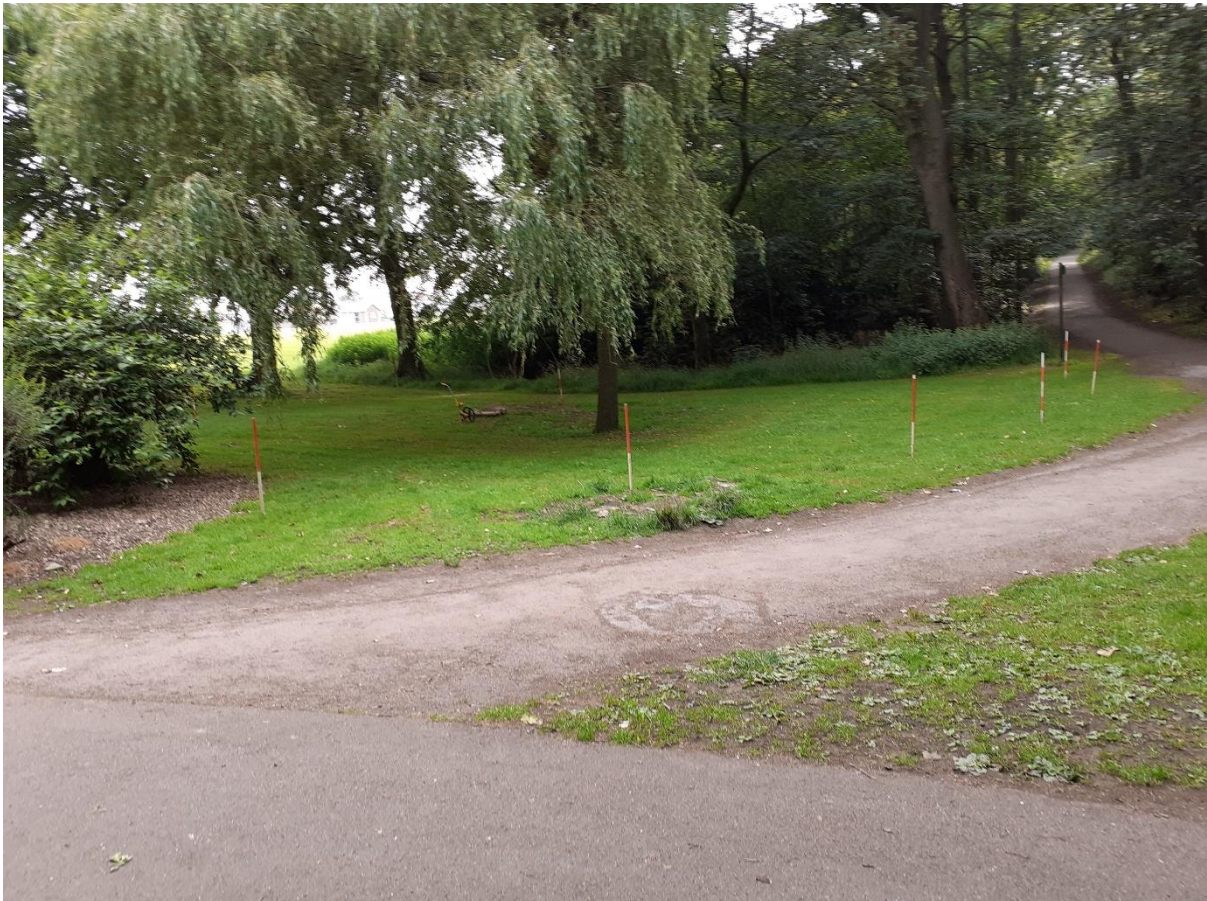
The pond has been infilled, presumably using infill material from when the coach house was demolished (provenance required). The inlet from the ditch has been piped with a 230mm pipework, through the centre of the pond to the outlet stream at Park Wood (found on the survey). Trees now grow surrounding and into the centre of the pond area. The ground depression where the pond was located can clearly be seen under examination.

Several large stones set at ground level have been found.

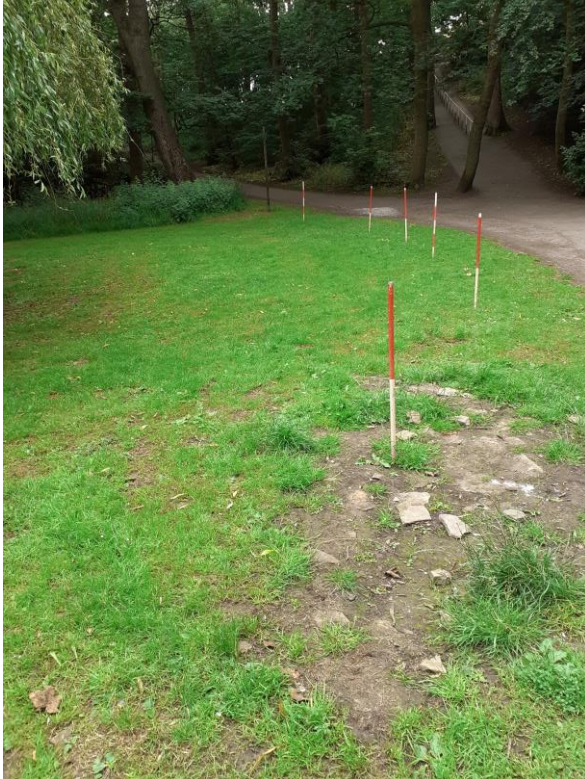
This shows evidence of the supporting wall for the original pathway. The stones can clearly be seen. It was exposed earlier in May 2019, when a terrier went down the 230mm (9inch) pipe (possibly after a rat) and got lodged in the centre of the pond. Park workers had to dig the dog out, which showed where the low wall was.

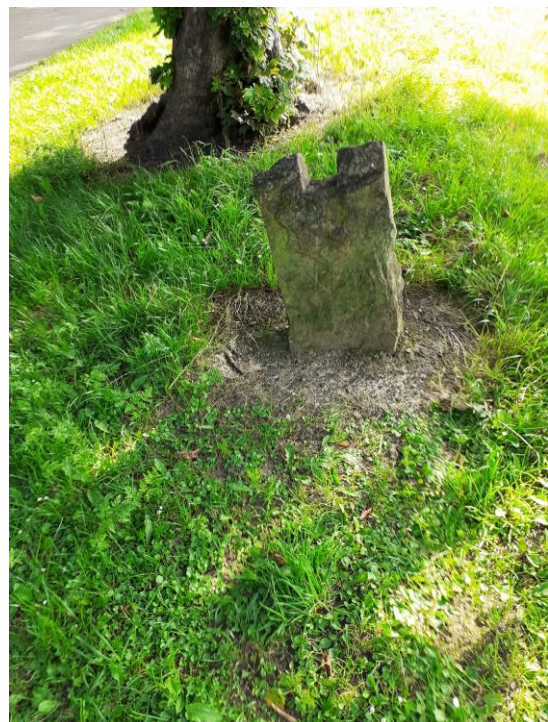
Stone fence post

A stone fence post has been located along the boundary of Summerhouse wood and the deer park at the end of the original pathway or track. (B)

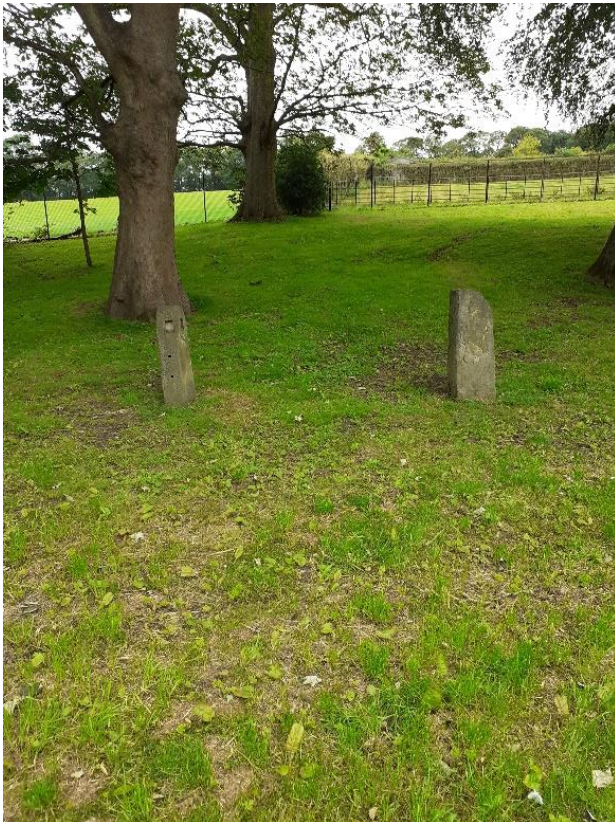
Continuation of the coach house pond track

This track used to proceed south across the deer park and passed through the two stone gateposts located on the field boundary at the top pond. (C) It then continued south up the hillside, connecting with the Norton Hall Farmhouse buildings. NB It would be ideal to reinstall this section of pathway across the deer park area to the top pond; which would achieve a circular walk around the deer park without affecting the animal farm.
